# **TESTING FOUNDATION TYPES DURING RADON SCREENING AND ITS IMPLICATIONS FOR CLIENT SAFETY AND MITIGATION**

Wallace O. Dorsey Jr., Radon-Ease Inc.

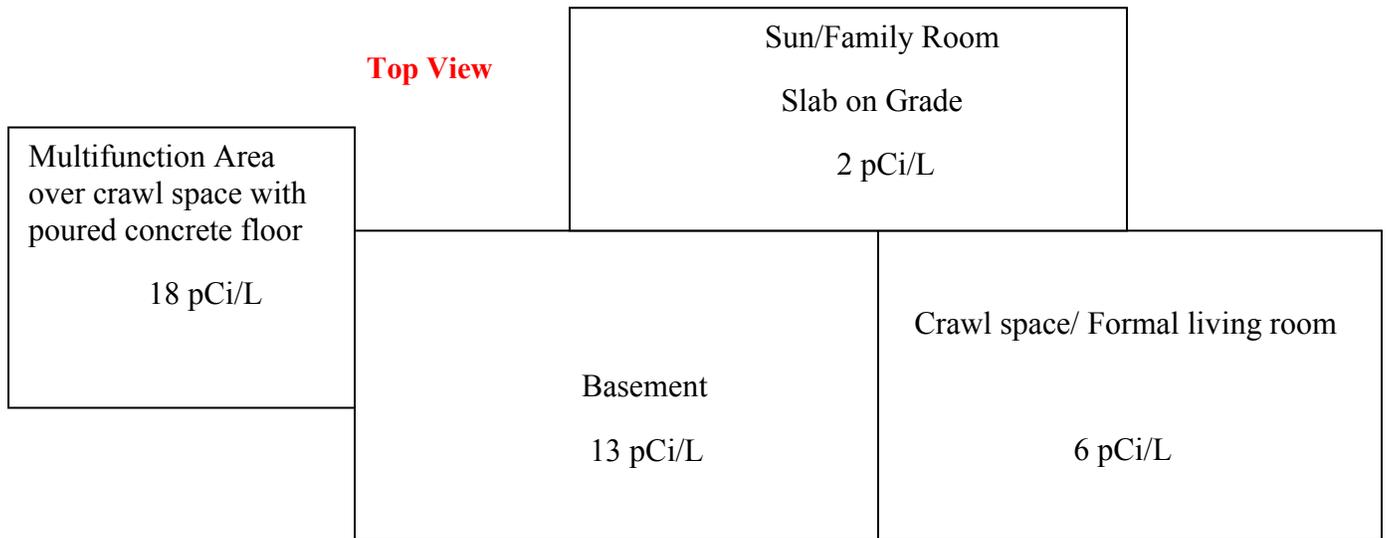
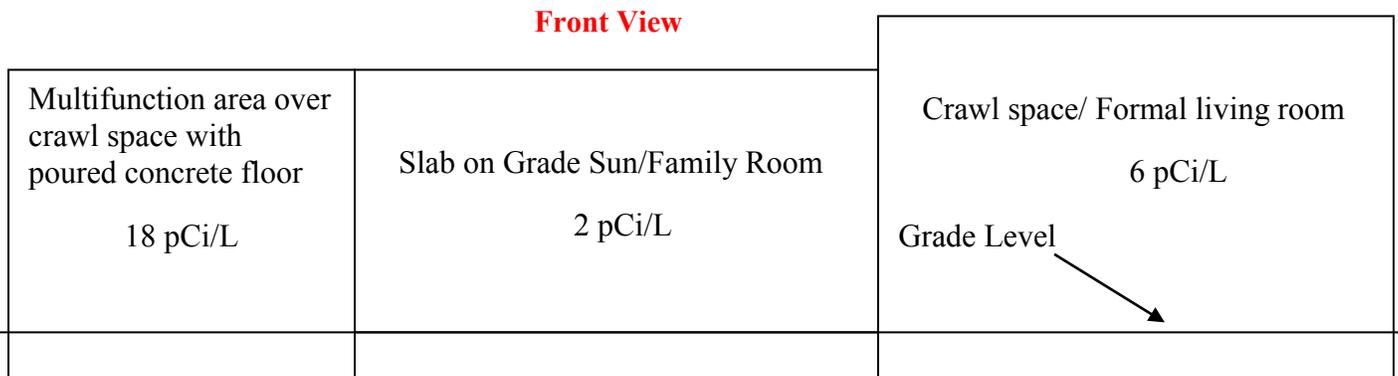
### Example # 1

Real estate transaction. CRM test. 1930s single-family detached residence with multiple slabs, basement and multiple concrete floored crawl spaces of commercial grade construction. Four CRMs were used. Initial tests showed readings that varied from 2 pCi/L in a slab-on-grade sun room, 13 pCi/L in the basement, 6 pCi/L in a formal living room that was slab-on-grade to 18 pCi/L in a multifunction family/dining/kitchen area that was the family’s gathering center for home work/video games/TV and computer usage. On all visitations to the home the family was congregated in that area on the sofas and chairs dispersed throughout the area. The multifunction area was over a crawl space that had a 4-inch concrete slab poured in it and also had the highest radon levels discovered in the home at 18 pCi/L. Mitigation was performed in the basement and the crawl spaces and reduced the basement levels to 3 pCi/L, the slab-on-grade formal living room to 2 pCi/L and the multifunction area to 5.5 pCi/L. Subsequent testing yielded similar results. Further mitigation was conducted in the multifunction area over the crawl space which then reduced the radon levels to less than 1 pCi/L in all living areas.

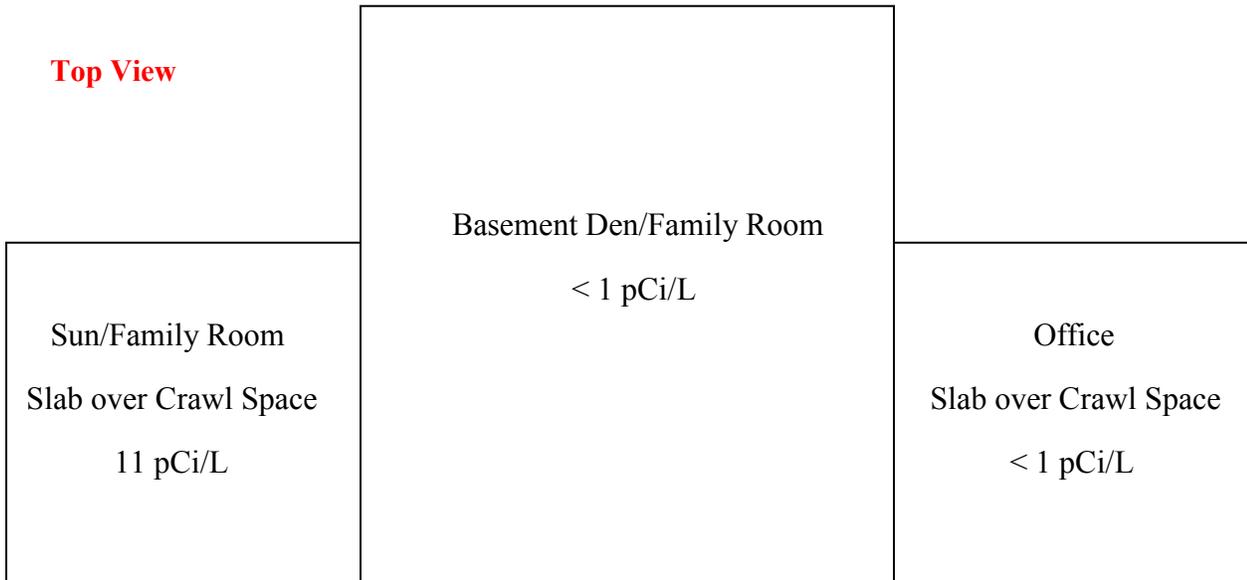
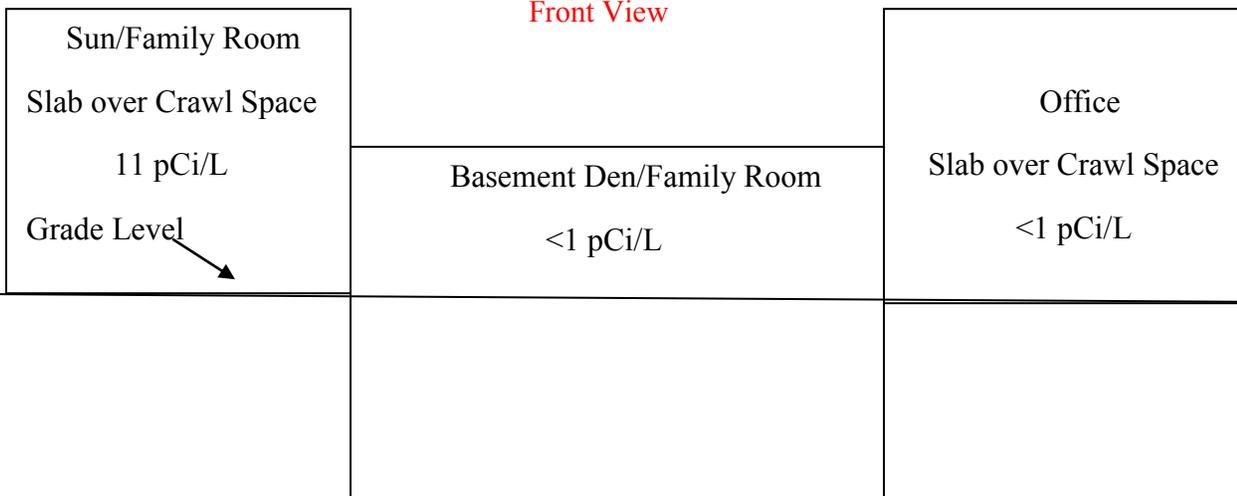
## Example 2

Test requested by homeowner. CRM Test. Three monitors deployed. 1960s single-family detached residence with a basement and two slabs over a crawl space. The basement results were <1 pCi/L, and an office that was a room with a slab over a crawl space was also <1 pCi/L. The sun/family room was the family gathering area, nicely furnished and outfitted with HVAC, television and computer station. This room had test results of 11 pCi/L. The homeowner indicated the family spent the bulk of their indoor waking hours in the space doing homework, watching TV and computer gaming. Post-mitigation results were less than 1 pCi/L in the sun room as well as the rest of the home.

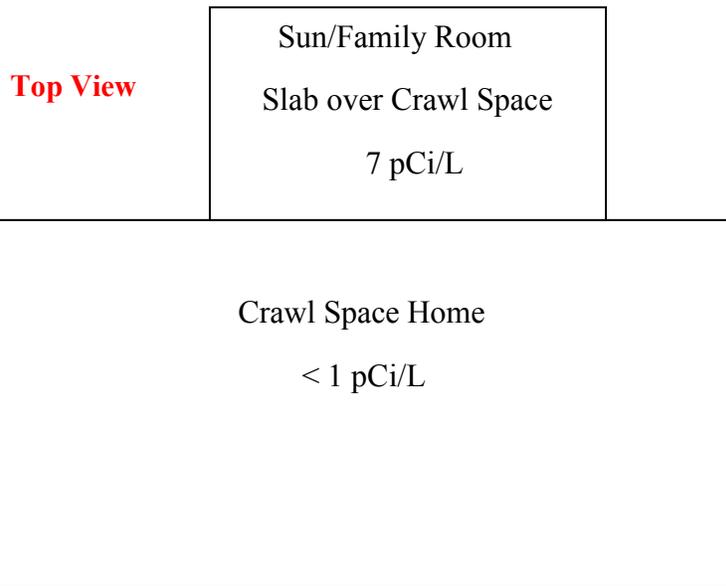
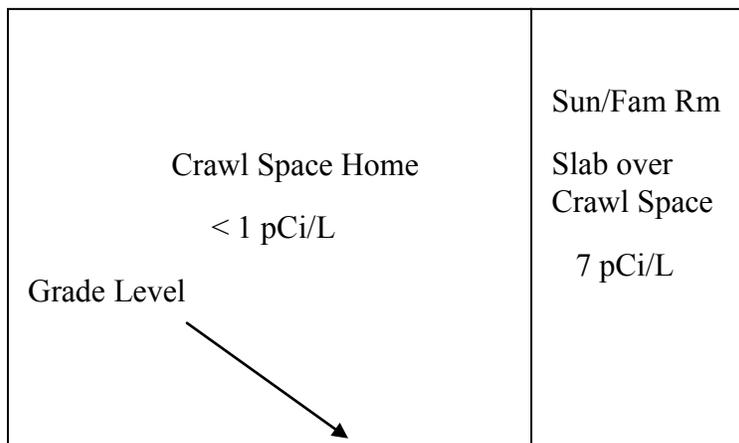
### Example 3

Real estate transaction. CRM test. Two monitors deployed. 1970s single-family detached home with crawl space, with a sun room that had a concrete slab over a crawl space. The family room over the crawl space yielded less than 1 pCi/L, sun/family room 7 pCi/L. The sun/family room was a nicely furnished, conditioned space with all of the crawl space vents open. It was once again the family's focal point for gatherings. Post-mitigation results yielded less than 1 pCi/L in both tested areas.

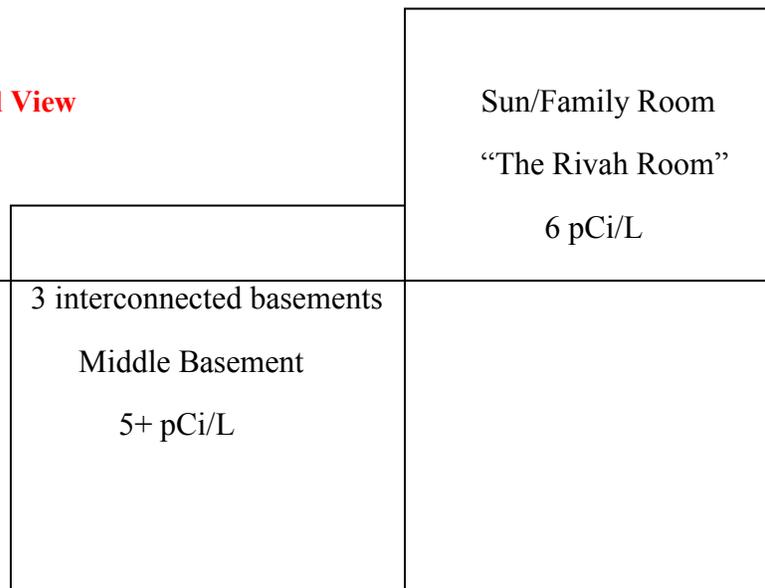
### Example 4

Real estate transaction. CRM test. Four monitors deployed. 1940s single-family residence with three interconnected basements and a sun/family room with a crawl space. The home already had two radon mitigation systems in place on opposite ends of the basement treating the two “new” basement additions; however, leaving the original core basement untreated, as was the sun/family room over the crawl space. The original home had one basement, subsequently another basement addition was added, then another at the opposite end of the home. The crawl space was added off of the back of the home as was a family/sun room. This was a focal point for family gatherings due to its extraordinary river views. The initial radon test yielded 2 pCi/L in a mitigated portion of the new basement, 1 pCi/L in a master bedroom that was over a new basement, 5.9 pCi/L in a den that was located in the original portion of the basement and 6 pCi/L in the sun/family room off of the back of the home over a crawl space with the foundation vents open. Subsequent mitigation was done in the original basement as well as the crawl space by tying one of the “new basement” mitigation systems to the old portion of the basement den as well as the crawl space. Post-mitigation testing showed results of < 1 pCi/L in all areas of the home.

<p>Mitigated “new basement” 2 pCi/L (1 pCi/L in MBR above)</p>	<p>Nonmitigated original basement Den 5+ pCi/L</p>	<p>Mitigated “new basement” Family room/Audio room 2 pCi/L</p>
--	--	--

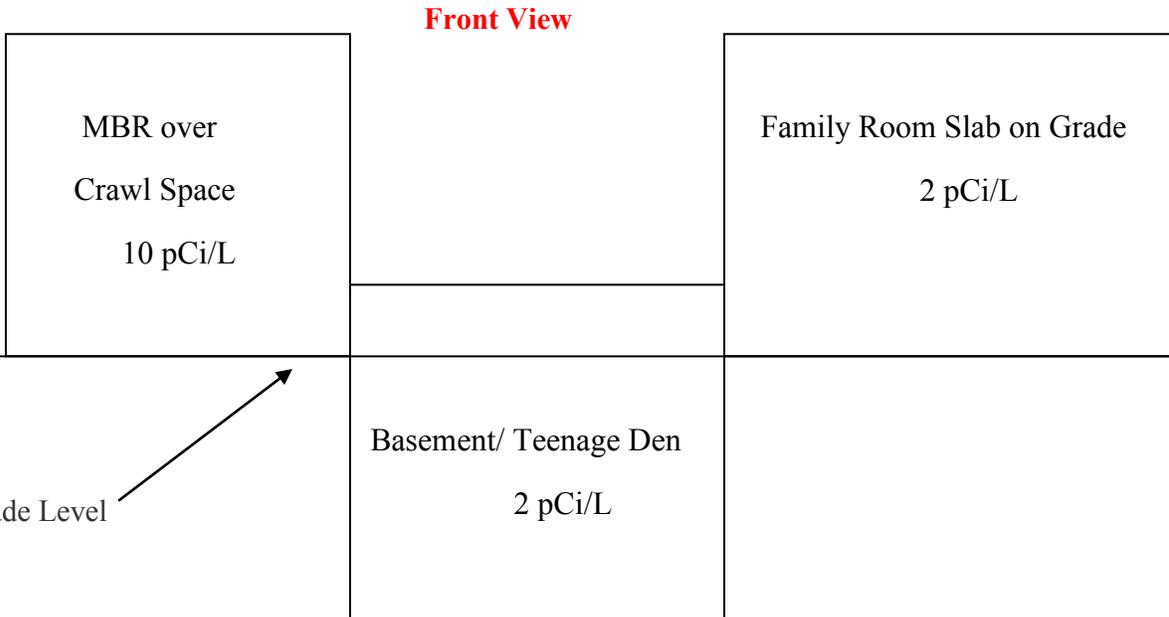
### Example 5

Test requested by homeowner. CRM test. Three monitors deployed. 1950s single-family residence comprised of a basement with a slab and a master bedroom addition over a crawl space. The basement was a utility room and teen hangout. The slab on grade was a garage converted into a very nice family room. The Crawl Space addition was a master bedroom and the “office” of the Realtor/Homeowner. The basement tested at >2 pCi/L. The slab-on-grade family room was also >2 pCi/L. The master bed room/office over the crawl space was >10 pCi/L.

MBR over Crawl Space 10+ pCi/L	Basement/Teenage Den 2 pCi/L	Family Room. Slab on Grade 2 pCi/L
-----------------------------------	---------------------------------	---------------------------------------

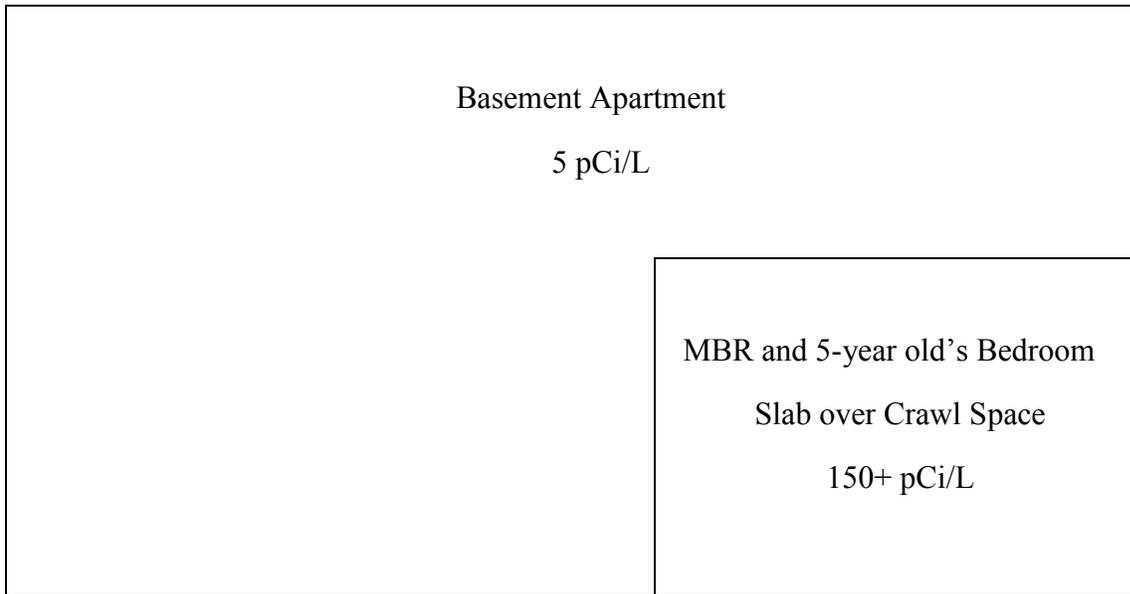
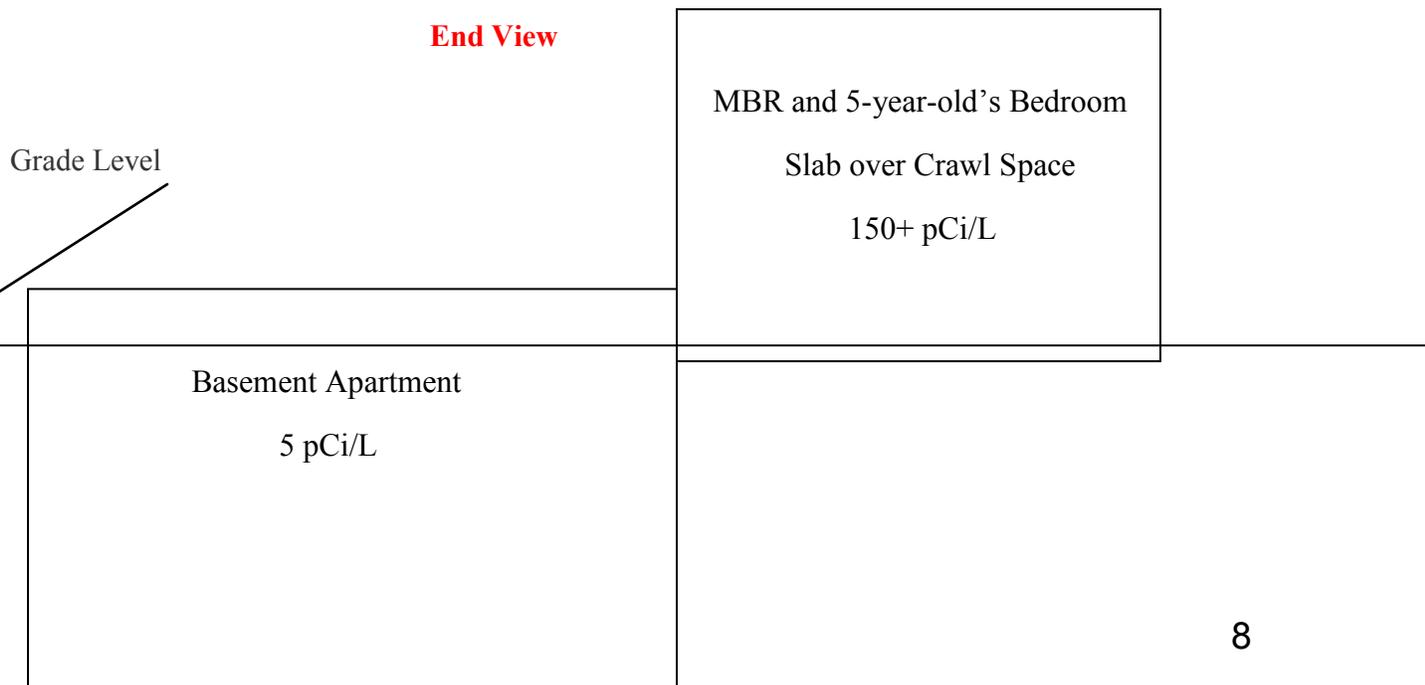
### Example 6

Real estate transaction. CRM Test. Two monitors deployed. 1950s single-family detached basement home with a slab over a crawl space that comprised a 5-year-old girl's bedroom and the master bedroom. The basement test result was 5 pCi/L. The little girl's slab-on-grade bedroom measured 157 pCi/L. This stunning difference in measurements prompted a second CRM test with duplicate monitors placed in each location. The subsequent testing yielded very similar results; 5 pCi/L in the basement and 161 pCi/L in the little girl's bedroom. Post-mitigation results were <1 pCi/L in both areas. Had the EPA's guidance been followed, the child would have been sleeping in a room with >150 pCi/L of radon.
